MSP430F235 Device Erratasheet

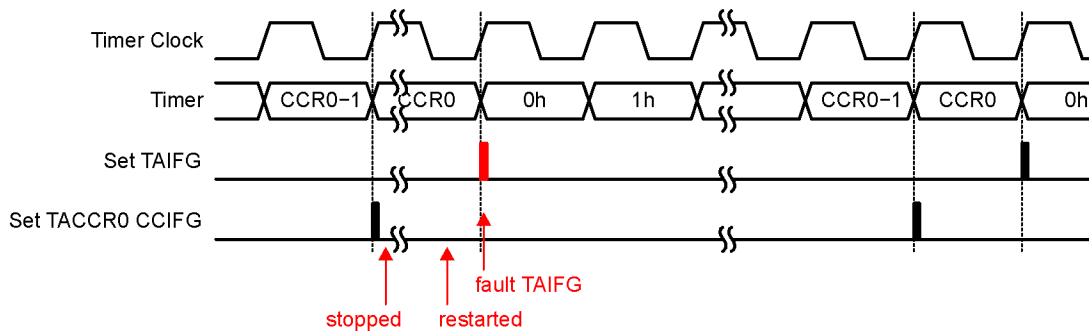
Workaround	Switch capture/compare mode to capture mode before the CCRx register increment. Switch back to compare mode afterwards.
TA16	<i>TIMER_A Module</i>
Function	First increment of TAR erroneous when IDx > 00
Description	The first increment of TAR after any timer clear event (POR/TACLR) happens immediately following the first positive edge of the selected clock source (INCLK, SMCLK, ACLK or TACLK). This is independent of the clock input divider settings (ID0, ID1). All following TAR increments are performed correctly with the selected IDx settings.
Workaround	None
TA21	<i>TIMER_A Module</i>
Function	TAIFG Flag is erroneously set after Timer A restarts in Up Mode
Description	In Up Mode, the TAIFG flag should only be set when the timer counts from TACCR0 to zero. However, if the Timer A is stopped at TAR = TACCR0, then cleared (TAR=0) by setting the TACLR bit, and finally restarted in Up Mode, the next rising edge of the TACLK will erroneously set the TAIFG flag.

Workaround None.

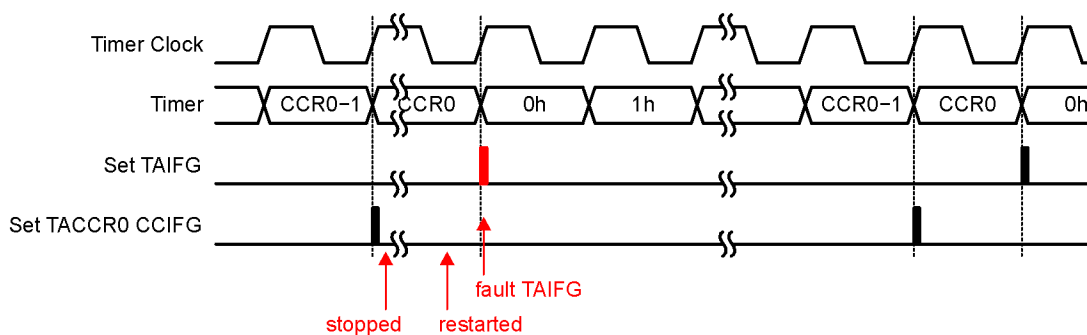
TB24 *TIMER_B Module*

Function	TBIFG Flag is erroneously set after Timer B restarts in Up Mode
Description	In Up Mode, the TBIFG flag should only be set when the timer resets from TBCCR0 to zero. However, if the Timer A is stopped at TBR = TBCCR0, then cleared (TBR=0) by setting the TBCLR bit, and finally restarted in Up Mode, the next rising edge of the TBCLK will erroneously set the TBIFG flag.

Workaround	None.
-------------------	-------
